# CLARENDON HERITAGE

North Clarendon Chapel

## Full Report 2025

## Clarendon Heritage – Report on Chapel 1871

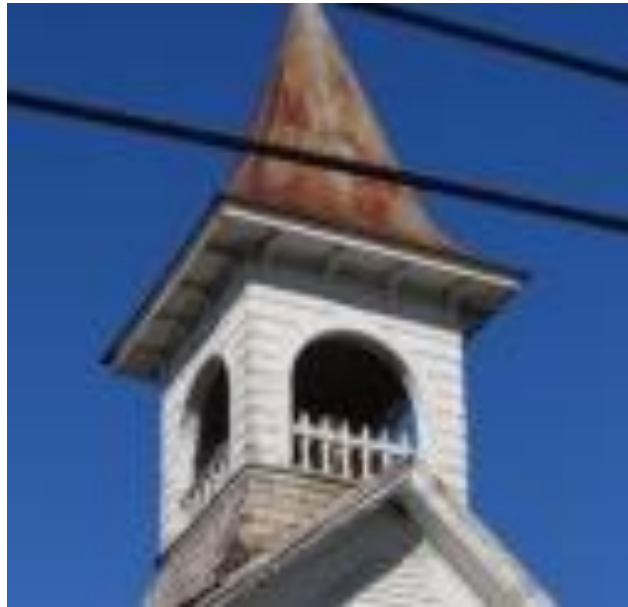
- Steeple

The open shingled belfry has a polygonal spire and its original bell.

A small 5' square wood-framed steeple rests on the peak of the roof at the east end, and has a rusty galvanized metal roof and ball finial; the metal appears sound but weathered, and has a ragged drip edge especially on the north side. The metal needs painting, and may have pin-hole deterioration that is characteristic of weathered galvanized roofing. This roof is a prime candidate for application of a liquid membrane consolidation such as Acrylabs ([www.acrylabs.com](http://www.acrylabs.com) Mitchell Weinberger Technical Representative Acrylic Roof Systems 37 County Road Lincoln, VT 05443 802-453-4648 phone 800-881-6195 phone 802-453-6438 fax); this product is designed to consolidate historic roofs, and will last longer and more effectively than just painting the rusty metal, which is the other option.

Below the metal roof a bracketed wood cornice encircles the eaves above round arched openings on all 4 sides; a low balustrade protects each opening, and the flared exterior of the steeple base is covered in painted wood shingles that are substantially deteriorated. Most of the base flashing is concealed but where visible it appears rusty and should be replaced with a nonferrous flashing. We could not observe the deck inside the railings, where a bell is apparently located; this is likely to be either flat seam soldered metal, or some form of membrane, and needs to be checked – with access via a lift or long ladder on the exterior as there is no connection from the attic – to determine any repairs needed.

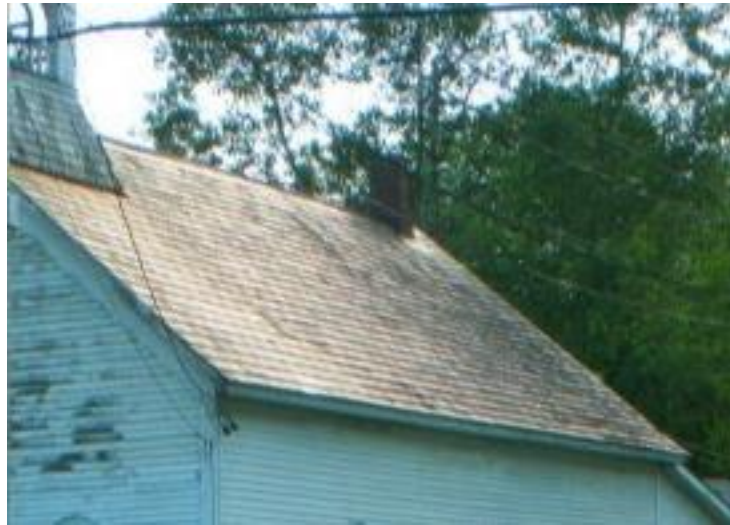
- **Roof**

Purple slate quarried in Vermont. It is a rare stone used for interior and exterior applications. It has superior properties and performance. It is uncommon and Its unique plum color and rich texture makes it very desirable.

The main roof is covered in purple slate nailed to the horizontal board roof deck, with a galvanized metal ridge cap; the small section of ridge cap east of the steeple is missing. A number of slates are hung on repair hooks. Approximately 12 slates on the south and six on the north are damaged, slipped or missing and need replacement; this is a yearly maintenance issue for slate roofs of this age. This roof appears to have been well-maintained, with relatively little current repair needed.

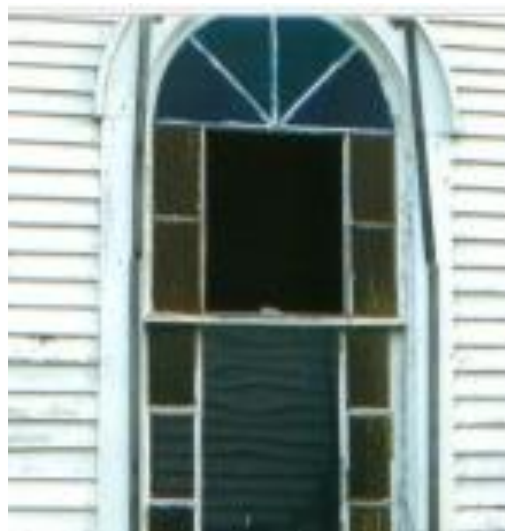
- **Windows**

On the south, a 6/6 wood double-hung window, and 9/11 Queen Anne wood double-hung windows with colored glass. On the east, 9/11 Queen Anne wood double-hung windows with colored glass. On the north, 9/11 Queen Anne wood double-hung windows with colored glass.

On the east, (2) 9/11 Queen Anne wood double-hung windows with colored glass have no storms and need sash conservation. A 4-panel wood door needs maintenance repairs.

On the north, (3) 9/11 Queen Anne wood double-hung windows with colored glass have no storms and need sash conservation. A 6/6 wood double-hung window with no storm needs major sash conservation, and a plank wood door needs maintenance repairs.

Sash conservation typically consists of removal of sash to a shop for complete disassembly and repair/re-glazing/re-painting, and prep/re-painting of the sill, jambs and casings before the sash is re-installed. It also includes provision of a secure security panel in the opening while the window is being repaired. Maintenance repairs can typically be done in place and involve lessextensive repairs to glazing, woodwork and finishes.

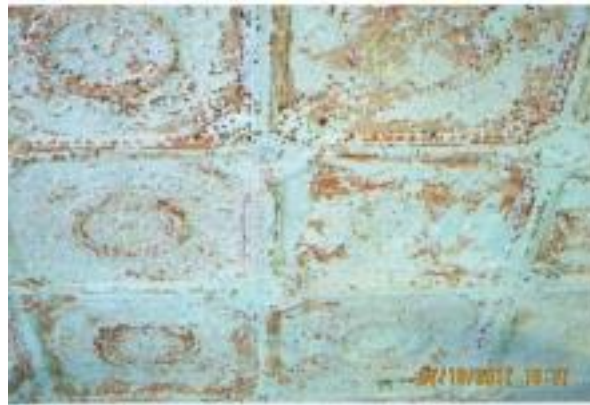
- **Ceiling**

Tin ceilings were manufactured in tin plate, and other metal sheets such as copper, steel, aluminum or stainless-steel panels. The metal was then stamped with complex and sophisticated patterns, copied and developed from which originally, could easily be shipped across North America the finest carved and molded plasterwork.

The Sanctuary, with 10 ½' ceiling, has worn carpet on the floor, plaster walls with a deteriorated plywood wainscot, and a pressed-tin cove and ceiling that is extensively rusted but largely intact. This could likely be consolidated with a material like Acrylabs liquid membrane; if fiberglass insulation in the attic is replaced, it might be possible to paint the back side of the tin as well, which is where much of the rust is occurring.

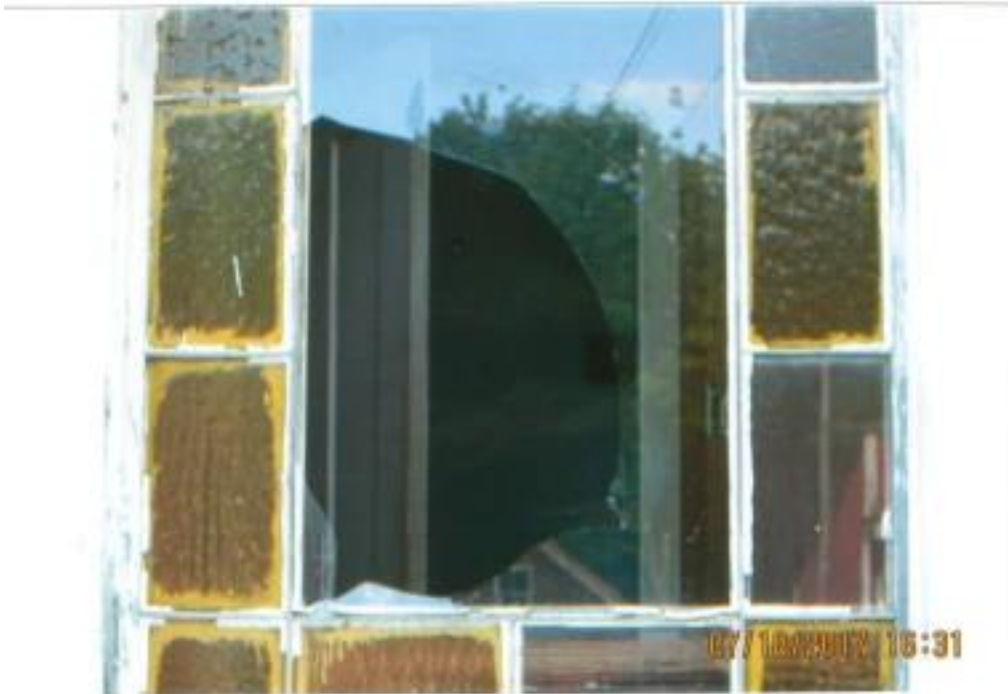
- **Arched Stained Windows**

All of the windows noted above require significant restoration work. This will require labelling and carefully removing all sash to a workshop for bench repairs. Many panes of colored glass are either damaged or missing entirely.

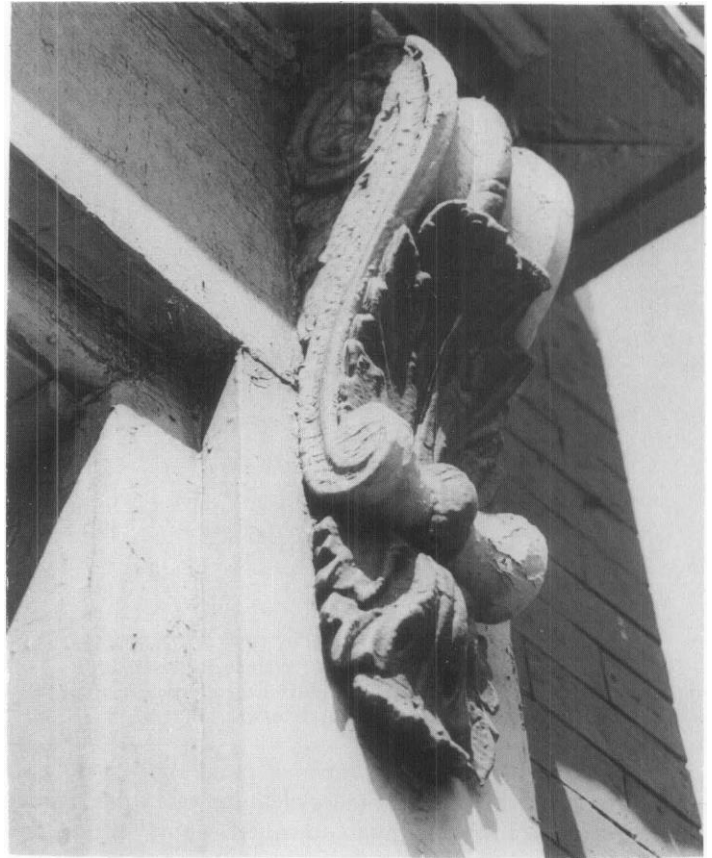
*Fig. 1 Excessive paint build-up on architectural details such as this ornamental bracket does not in itself justify total paint removal. If paint is cracked and peeling down to bare wood, however, it should be removed using the gentlest means possible. Photo: David W. Look, AIA.*

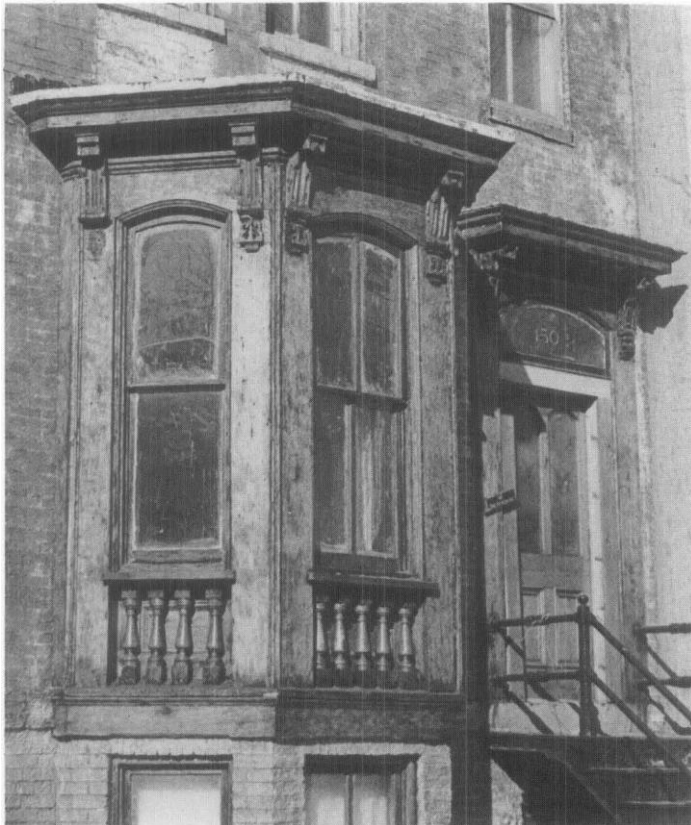
*Fig. 2 A traditionally painted bay window has been stripped to bare wood, then varnished. In addition to being historically inaccurate, the varnish will break down faster as a result of the sun's ultraviolet rays than would primer and finish coats of paint. Photo: David W. Look, AIA.*

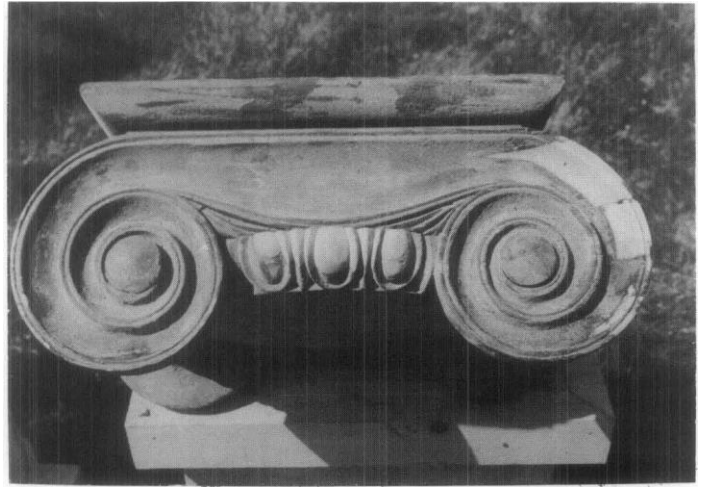
*Fig. 3 If damage to parts of a wooden element is severe, new sections of wood will need to be pieced-in. When such piecing is required, paint on the adjacent woodwork should be removed so that the old and new woods will make a smooth profile when joined. After repainting, the repair should be virtually impossible to detect. Photo: Morgan W. Phillips.*

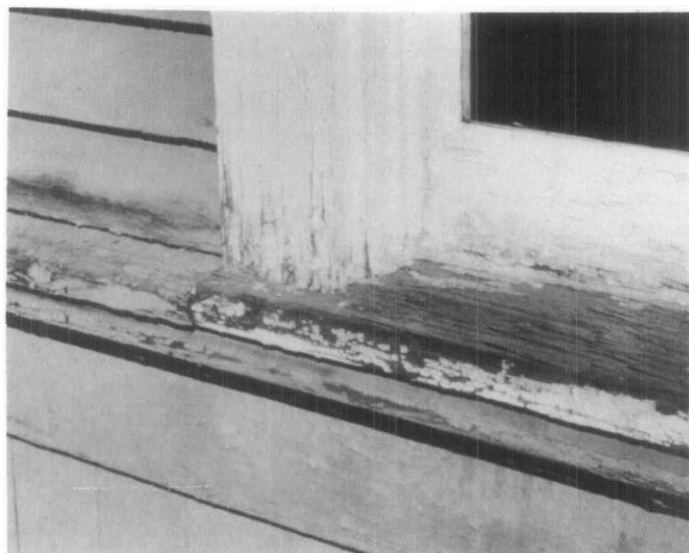
*Fig. 4 Paint films wear unevenly depending on exposure and location. Exterior locations which are susceptible to accelerated deterioration are horizontal surfaces such as windowsills.*

*These and similar areas will require repainting more often than less vulnerable surfaces. In the case of this window sill where paint has peeled off and adjacent areas have cracked and alligated, the paint should be totally removed. Prior to repainting, any weathered wood should be rejuvenated using a solution of 3 cups exterior varnish, 1 oz. paraffin wax, and mineral spirits/ paint thinner/or turpentine to make 1 gallon. Liberal brush application should be made.*

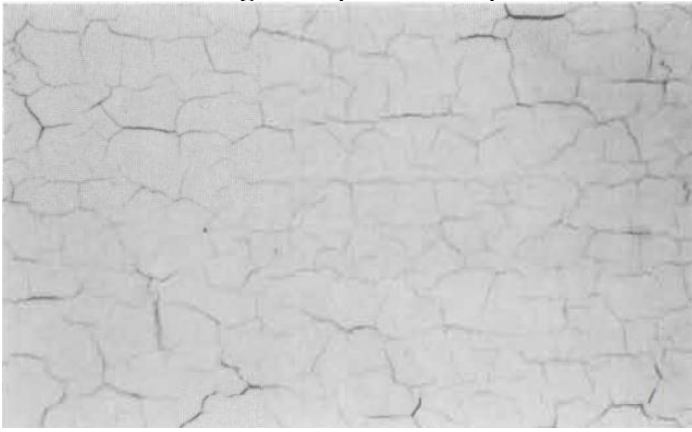
*Fig. 5 Crazing—or surface cracking—is an exterior surface condition which can be successfully treated by sanding and painting. Photo: Courtesy, National Decorating Products Association.*

Crazing can be treated by hand or mechanically sanding the surface, then repainting. Although the hairline cracks may tend to show through the new

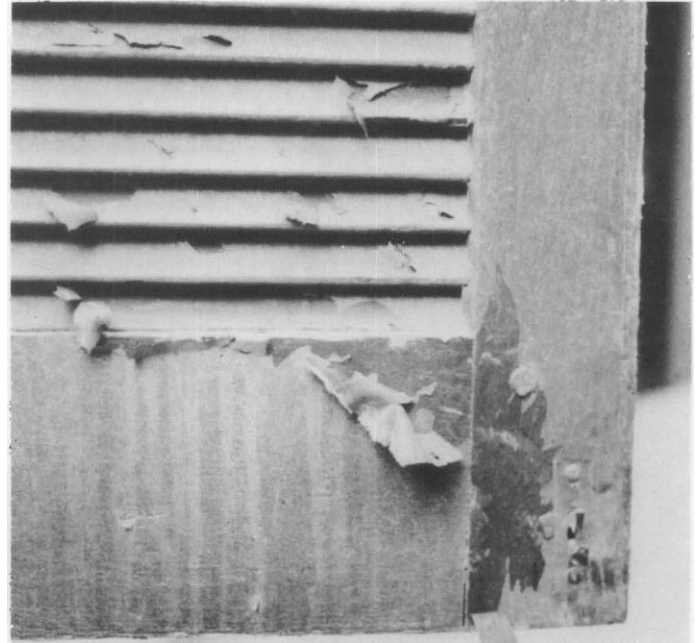
*Fig. 6 This is an example of intercoat peeling. A latex top coat was applied directly over old oil paint and, as a result, the latex paint was unable to adhere. If latex is being used over oil, an oilbase primer should be applied first. Although much of the peeling latex paint can be scraped off, in this case, the best solution may be to chemically dip strip the entire shutter to remove all of the paint down to bare wood, rinse thoroughly, then repaint. Photo: Mary L. Oehrlein, AIA.*

Where peeling was the result of using incompatible paints, the peeling top coat should be scraped and hand or mechanically sanded. Application of a high quality oil type exterior primer will provide a surface over which either an oil or a latex topcoat can be successfully used.

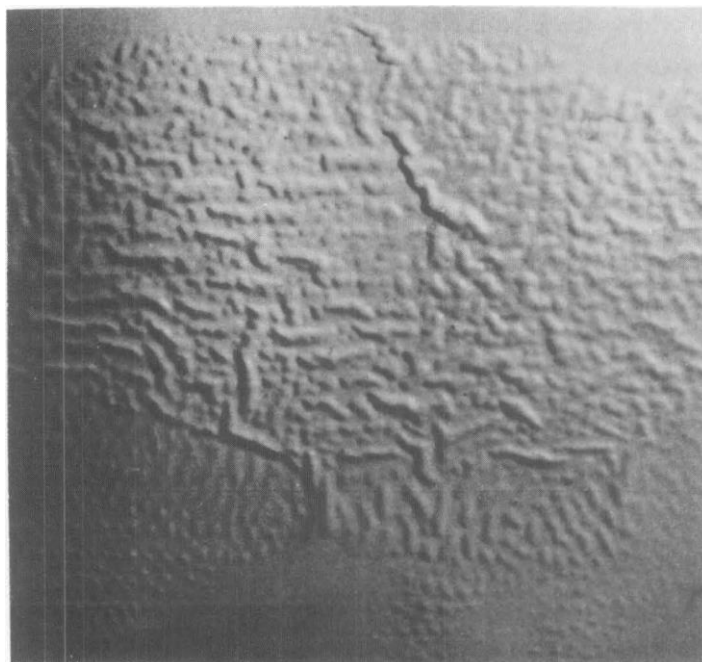
*Fig. 7 Wrinkled layers can generally be removed by scraping and sanding as opposed to total paint removal. Following manufacturers' application instructions is the best way to avoid this surface condition. Photo: Courtesy, National Decorating Products Association.*

The wrinkled layer can be removed by scraping followed by hand or mechanical sanding to provide as even a surface as possible, then repainted following manufacturer's application instructions.

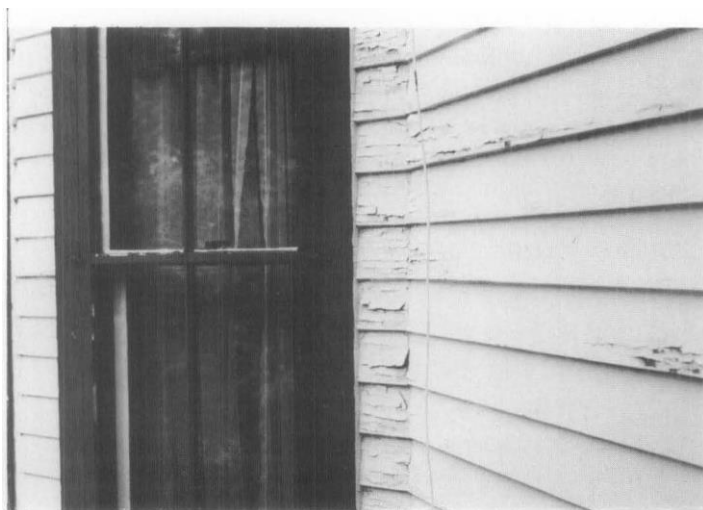
*Fig. 8 Peeling to bare wood—one of the most common types of paint failure—is usually caused by an interior or exterior moisture problem. Photo: Anne E. Grimmer.*

moisture, not only because moisture will jeopardize the protective coating of paint but because, if left unattended, it can ultimately cause permanent damage to the wood. Excess interior moisture should be removed from the building through installation of exhaust fans and vents. Exterior moisture should be eliminated by correcting the following conditions prior to repainting: faulty flashing; leaking gutters; defective roof shingles; cracks and holes in siding and trim; deteriorated caulking in joints and seams; and shrubbery growing too close to painted wood. After the moisture problems have been solved, the wood must be permitted to dry out thoroughly. The damaged paint can then be scraped off with a putty knife, hand or mechanically sanded, primed, and repainted.

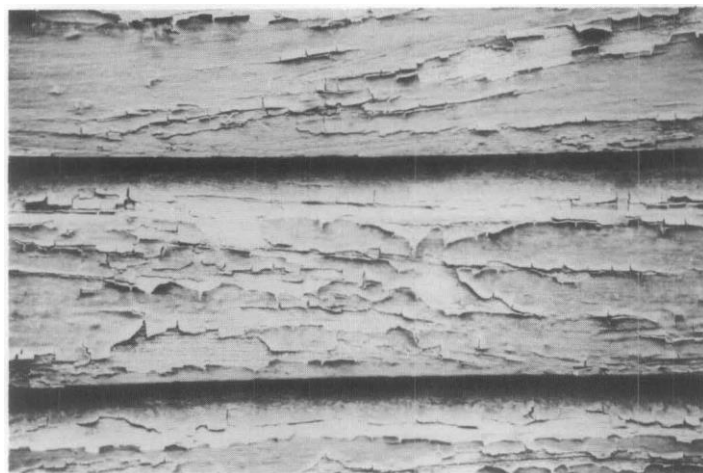
*Fig. 9 Cracking, alligatoring, and flaking are evidence of longterm neglect of painted surfaces. The remaining paint on the clapboard shown here can be removed with an electric heat plate and wide-bladed scraper. In addition, unsound wood should be replaced and moisture problems corrected before primer and top coats of paint are applied. Photo: David W. Look, AIA.*

If cracking and alligatoring are present only in the top layers they can probably be scraped, hand or mechanically sanded to the next sound layer, then repainted. However, if cracking and/or alligatoring have progressed to bare wood and the paint has begun to flake, it will need to be totally removed. Methods include scraping or paint removal with the electric heat plate, electric heat gun, or chemical strippers, depending on the particular area involved. Bare wood should be primed within 48 hours, then repainted.

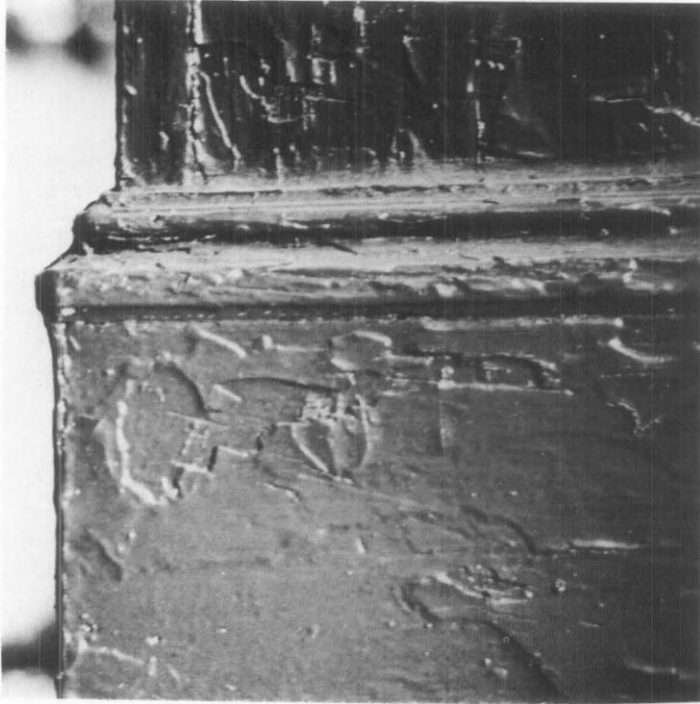
*Fig. 10 An excellent example of inadequate scraping before repainting, the problems here are far more than cosmetic. This improperly prepared surface will permit moisture to get behind the paint film which, in turn, will result in chipping and peeling. Photo: Baird M. Smith, AIA.*

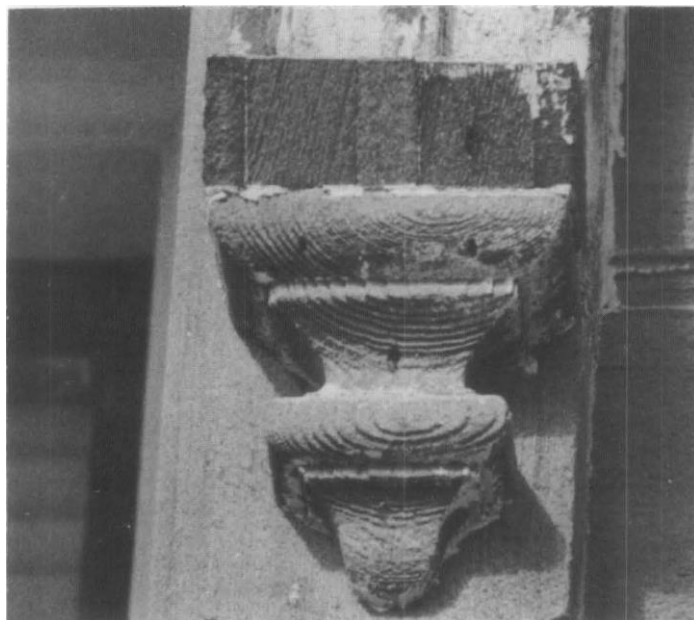
*Fig. 12 Sandblasting has permanently damaged this ornamental bracket. Even paint will not be able to hide the deep erosion of the wood. Photo: David W. Look, AIA.*
