# CLARENDON HERITAGE

North Clarendon Chapel

## Full Report 2025

## Clarendon Heritage – Report on Chapel 1871

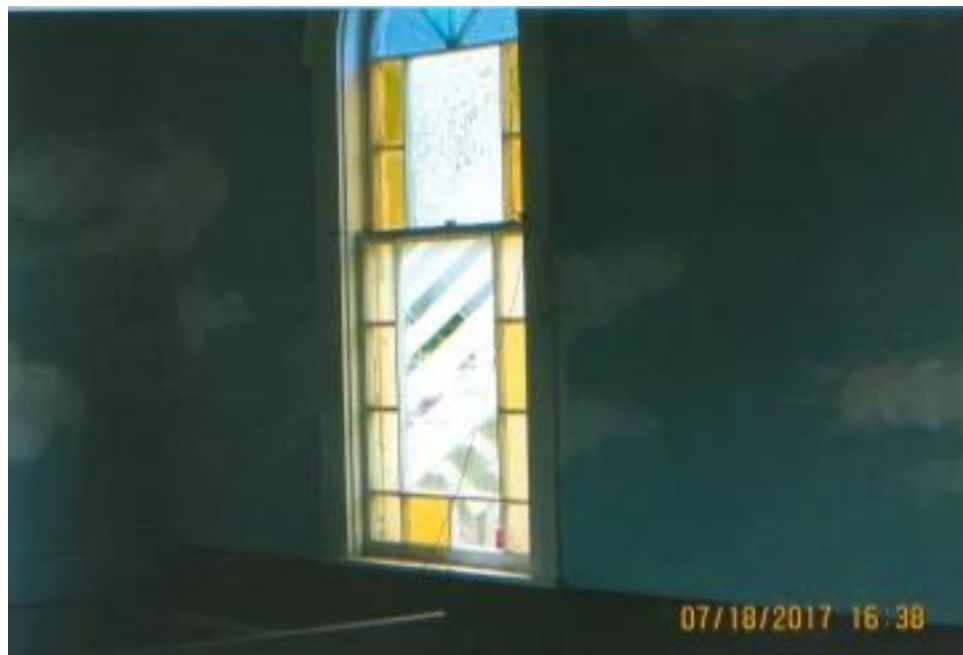
Window Condition Assessment made by Jackson Evans in June of 2019

All of the windows noted above require significant restoration work. This will require labelling and carefully removing all sash to a workshop for bench repairs. Many panes of colored glass are either damaged or missing entirely.

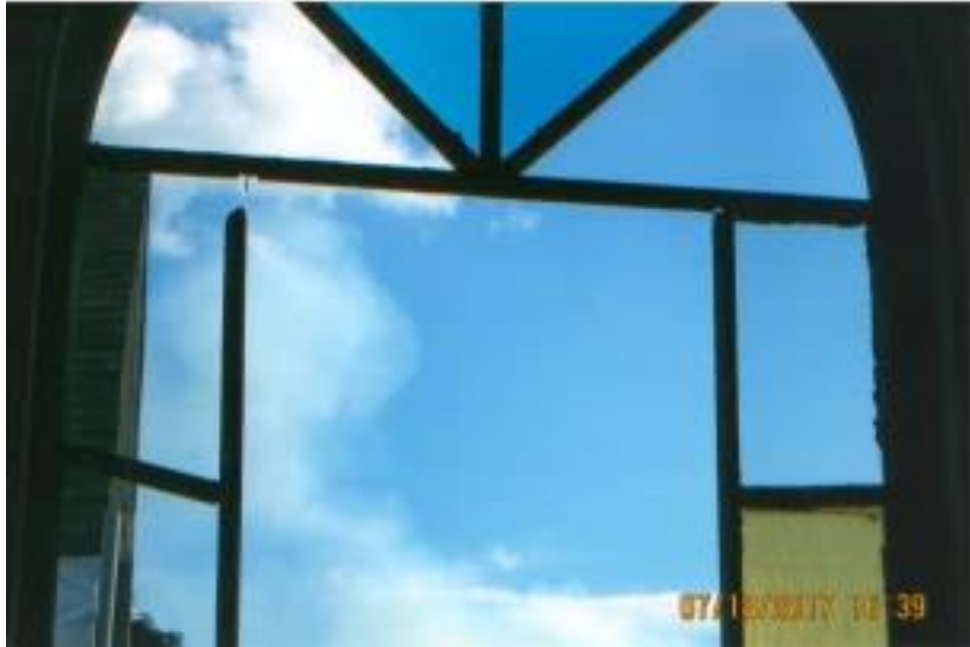
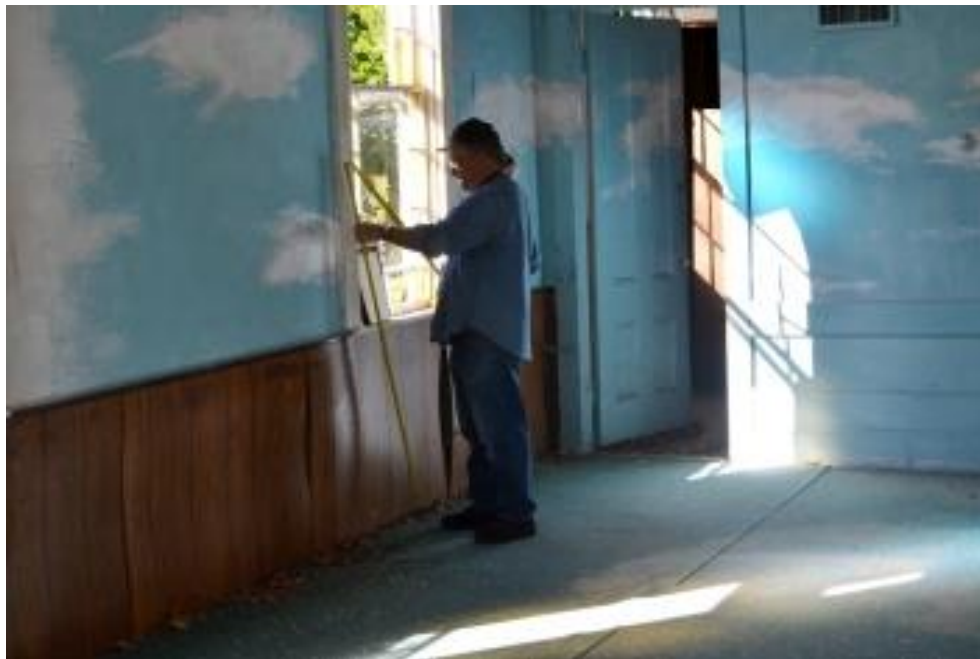
The sash windows in the main sanctuary at the North Clarendon Chapel are comprised of eight (8) arched top double hung sash wood frames in a Queen Anne style. The upper glazed arch on the top sash displays four glass panes of colored glass arranged in an array and supported visually by two stacked colored glass panes below surrounding a large central clear or frosted pane. The bottom sash displays 10 small colored panes surrounding a large central pane on the sides and bottom. The rear addition to the sanctuary contains two (2) six-over-six double hung wood sash windows with clear glass.
